Manhole Inspection Summary

Manhole # S47I2_004MH

Insp Date: **1/10/08 2:04 PM**

Location Address: **4701 Pennington Ave**

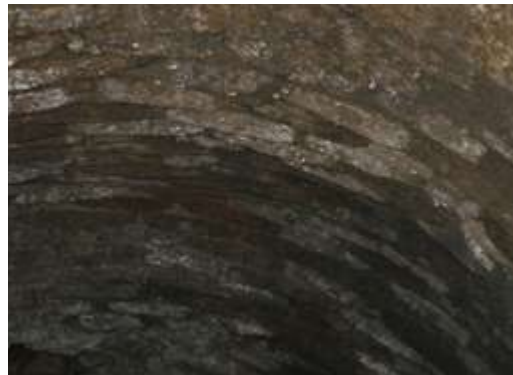
Defect 2

Infiltration: ☐ None ☐ Joint ☐ Cracks ☐ Mortar ☐ Roots ☒ **Wall**

infiltration on barrel and corbel

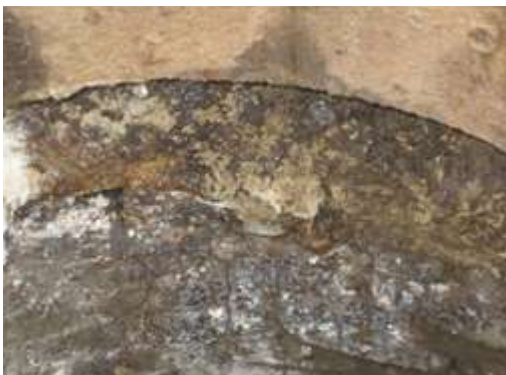
Defect 1

Condition: ☐ Sound ☐ Cracked ☐ Root Intrusion ☒ **Loose Brick** ☐ Deteriorated

Infiltration: ☐ None ☐ Joint ☐ Cracks ☒ **Mortar** ☐ Roots ☒ **Wall**

loose/missing brick on chimney

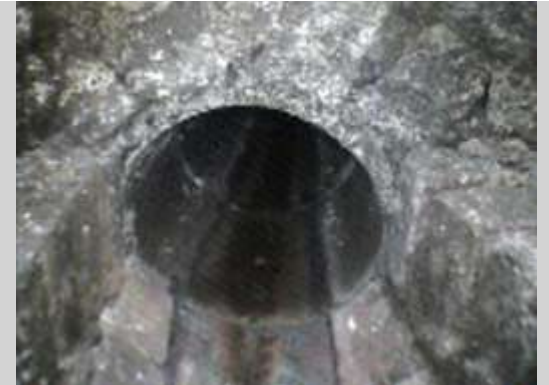
12 O'Clock Outflow

8 in. Circular Gravity Sewer
Pipe Out @ 12 O'Clock

Pipe Height: **9.6** (in.) Rod and Bar (Angled)
Pipe Material: **Clay** ☐ Pipe Lined
Invert Depth: **7.92** (ft.) Flow Characteristics: **None**
Deposits: ☒ None ☐ Mud ☐ Sludge ☐ Debris ☐ Grease
Silt Depth: (in.) Deposits Extent:
Infiltration: **None** Pipe Seal Cond: **Sound**

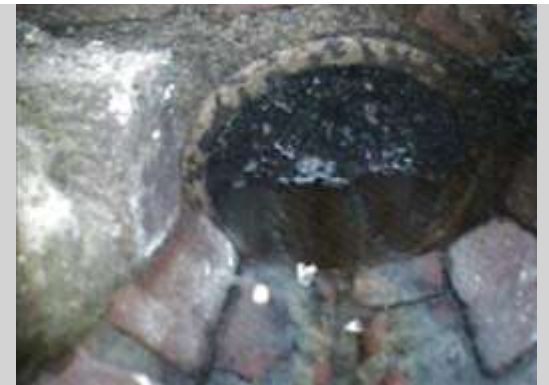
6 O'Clock Inflow

6 in. Circular Service Sewer
Pipe In @ 6 O'Clock

Pipe Height: **8.4** (in.) Rod and Bar (Angled)
Pipe Material: **Clay** ☐ Pipe Lined
Invert Depth: **7.87** (ft.) Flow Characteristics: **None**
Deposits: ☒ None ☐ Mud ☐ Sludge ☐ Debris ☐ Grease
Silt Depth: (in.) Deposits Extent:
Infiltration: **None** Pipe Seal Cond: **Sound**
